Adjusting the latch rod assembly on a C Series toolbox

Adjust the latch rod assembly on a C Series toolbox when...

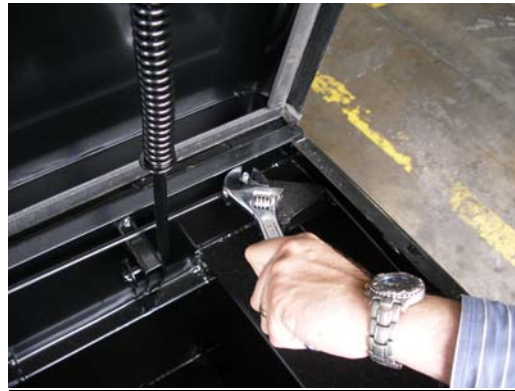
First, loosen the screw on the *latch control plate* (located on the passenger side front corner next to the cab).
